2022 Lake Parker Water Quality Monitoring Results: Lay Monitoring Program and LaRosa Partnership Program

Mark Mitchell, Lake Monitoring and Community Outreach Coordinator
VT Department of Environmental Conservation, UVM Lake Champlain Sea Grant

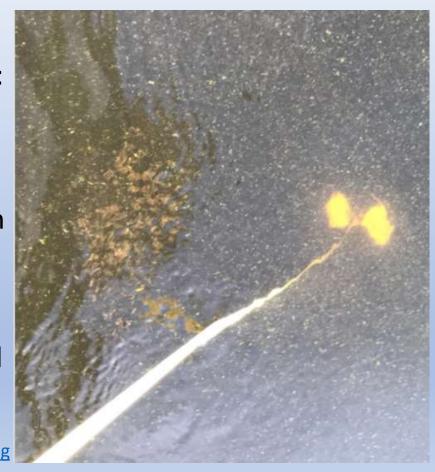
- Weekly from Memorial Day to Labor Day (minimum of 8 samples for summer mean):
 - Basic Sampling: Measure Secchi disk transparency depth (clarity)
 - Supplemental Sampling: Collect water samples with hose at twice Secchi depth that are lab tested for total phosphorus (nutrient) concentration and chlorophyll-a (algae) concentration
 - Complete a lake sampling webform (and report cyanobacteria conditions)
